## **ANNUAL REPORT FOR 2008**

Little River Bridge Mitigation Site Moore County TIP No. R-0210A

Prepared By:
Natural Environment Unit & Roadside Environmental Unit
North Carolina Department of Transportation
December 2008

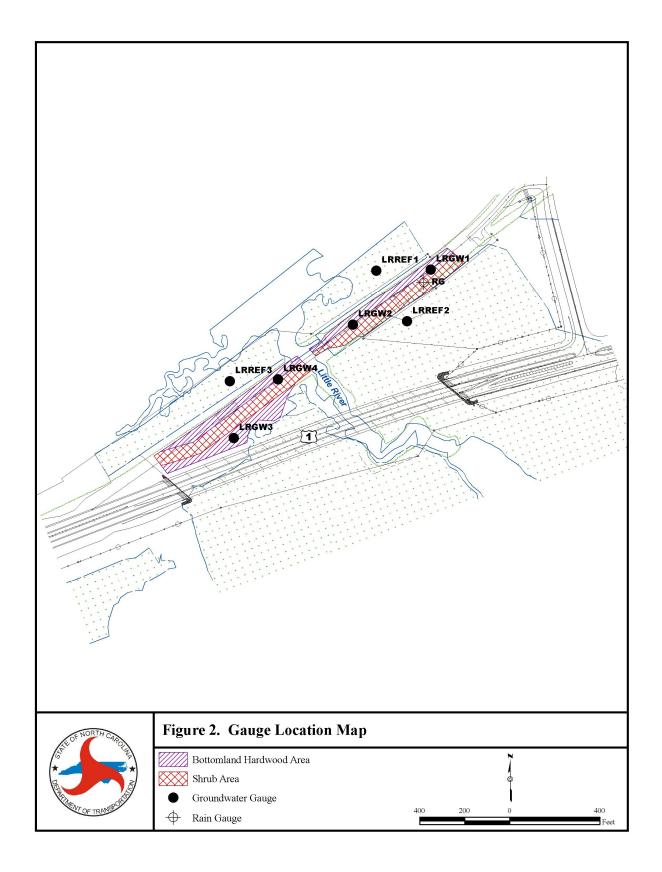
Figure 2. Monitoring Gauge Location Map

Four groundwater monitoring gauges were installed within the site's restoration area (Figure 2) in February 2006. There are also three reference gauges that were installed prior to construction in the existing wetlands that are adjacent to the constructed site. A rain gauge is also located on the site to assist in comparison of the rainfall data (supplied by the NC State Climate Office) from an official weather station in Carthage. The groundwater gauges record water levels on a daily basis.

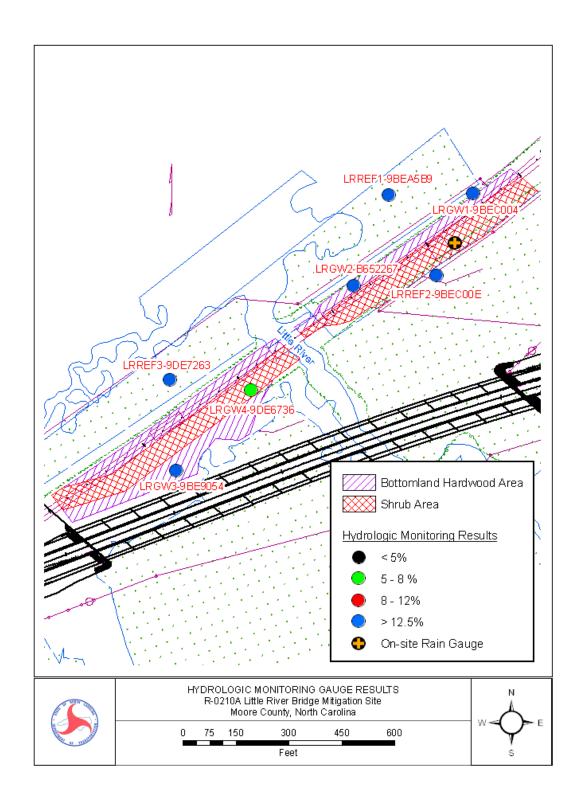
Figure 3. Hydrologic Monitoring Results

The maximum number of consecutive days that saturation occurred within 12 inches of the ground surface was determined for each groundwater monitoring gauge. This number was converted into a percentage of the 228-day growing season (March 23 – November 7). Table 1 provides the 2008 hydrologic results; Figure 3 is a graphical representation of these results. Appendix A includes graphs of the data recorded at each groundwater gauge. Daily rainfall events recorded at the onsite rain gauge are included on each of the groundwater gauge plots.

Groundwater Monitoring Gauge 4 did not meet the success criterion in 2008. The close proximity to the Little River may be causing a drawdown effect on the gauge. NCDOT will continue to monitor this gauge and may install additional gauges if necessary to determine whether or not wetland hydrology is present in this portion of the site.

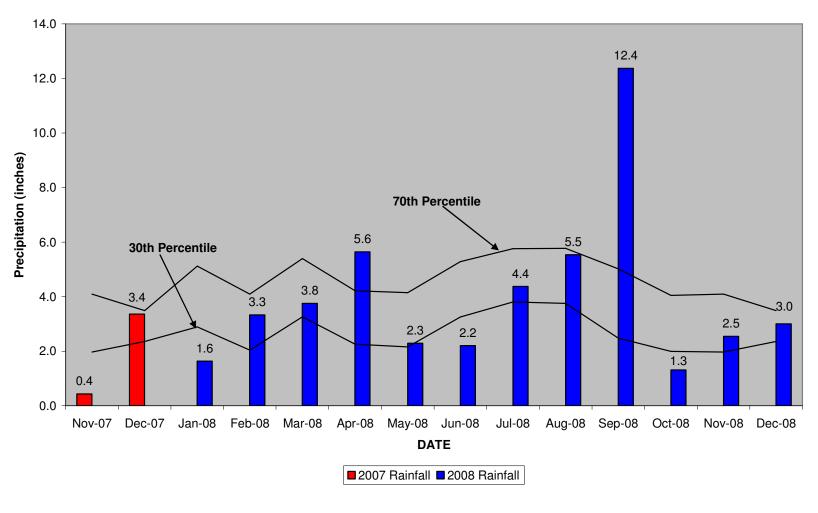
Figure 4. 30-70 Percentile Graph

Figure 4 is a comparison of the 2008 monthly rainfall to the historical precipitation (collected between 1977 and 2008) for Carthage, North Carolina. This comparison gives an indication of how 2008 relates to historical data in terms of climate conditions. The NC State Climate Office provided all historical rainfall information. For 2008, January, June, and October recorded below average rainfall. The months of February, March, May, July, August, November, and December recorded average rainfall, while April and September recorded above average rainfall. Overall, 2008 was an average rainfall year.
